NASA Technical Memorandum 104514

On Protection of Freedom's Solar Dynamic Radiator from the Orbital Debris Environment Part 2: Further Testing and Analyses

Jennifer L. Rhatigan
Lewis Research Center
Cleveland, Ohio

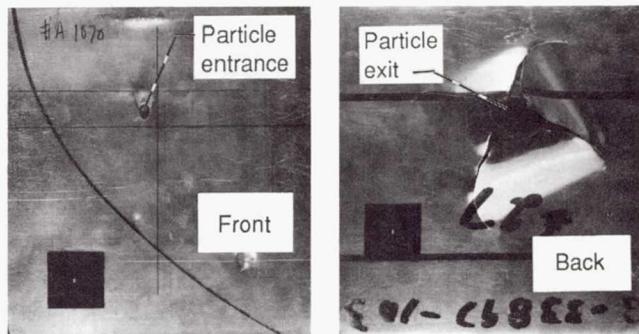
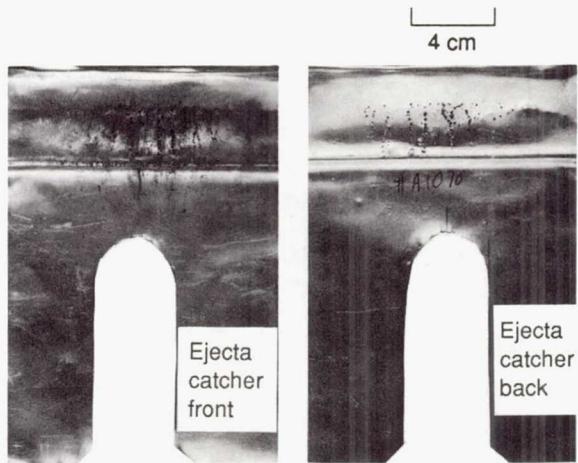
Figure 5.—Example of test article damage.

Figure 5 shows the result of a 2.38 mm aluminum sphere impacting at a 60° angle at 6.95 km/sec (HIRL Shot A1070). Note the small entrance hole on the front sheet and the petalled hole in the back facesheet. Generally, high obliquity shots had less rear facesheet petaling; that is, a 45° shot exhibited a larger petalled area than an equivalent 60° shot. However, the witness plates mounted behind oblique shots do not have a great deal of damage. As displayed in Fig. 5, the witness plate is coated with black powder debris and is severely deformed, but only exhibits a few fragment impacts that left dimples on the witness back surface and no perforations. This indicates that the projectile debris that exited the panel contained no large fragments and produced a primarily impulsive load to the witness plate.

The ejecta catcher plates, on the other hand, had multiple perforations with many of these concentrated near the surface of the panel. As demonstrated by comparing the damage patterns in the ejecta catchers, the damage from secondary ejecta debris increases substantially as impact obliquity angle increases. A detailed analysis of the ejecta catchers should be performed to correlate damage extent with impact conditions, and to make quantitative predictions of the secondary debris hazards to nearby structures such as the solar dynamic concentrator assembly.

HIRL shot A1070
 Projectile 2.380 mm Al-2017T4
 Velocity 6.95 km/sec
 Impact angle 60 degrees

(a) Front of test article.

(b) Back of test article.

Ejecta catchers, (c) front; (d) back; "unfolded" from test configuration.

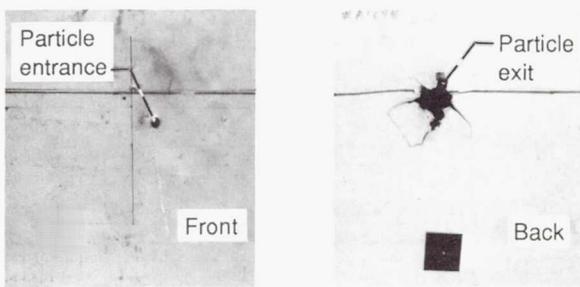
Figure 6.—Example of damage to coated test article.

Damage to a coated radiator panel from HVI is given in Fig. 6. A 2.0 mm aluminum sphere impacting at 45° and 6.83 km/sec created a petalled hole on the coated facesheet of the rear of the panel. The coating remained relatively intact, and even adhered to a large portion of the surface area of the petals in the facesheet.

HIRL shot A1070
 Projectile 2.380 mm Al-2017T4
 Velocity 6.95 km/sec
 Impact angle 60 degrees

(a) Front of test article.

(b) Back of test article.
